# HISTORIC STRUCTURE REPORT

## Harrisburg Transportation Center

## **Harrisburg Transportation Center Preliminary Design Project City of Harrisburg, Dauphin County, Pennsylvania**

October 2018

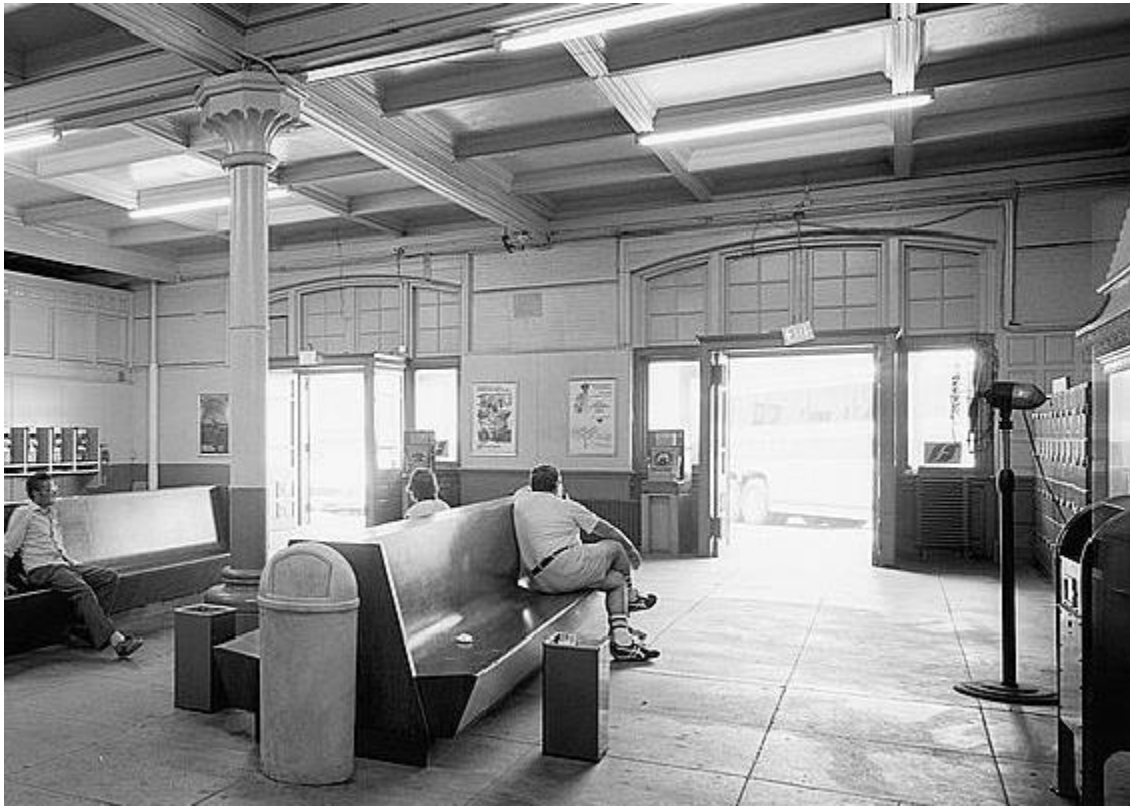
*Figure 9: Detail of a 1981 photograph showing interior entrance vestibules (HAER PA-85-9).*

**State of Preservation:** Even though modifications have been made to the entrance vestibules, they remain for the most part unchanged. The exterior pair of doors were replaced by visually incompatible doors. Historic hardware, such as hinges, kickplates, and "push-pull" signs have disappeared. All natural oak surfaces have been painted and panes of glass are soiled.

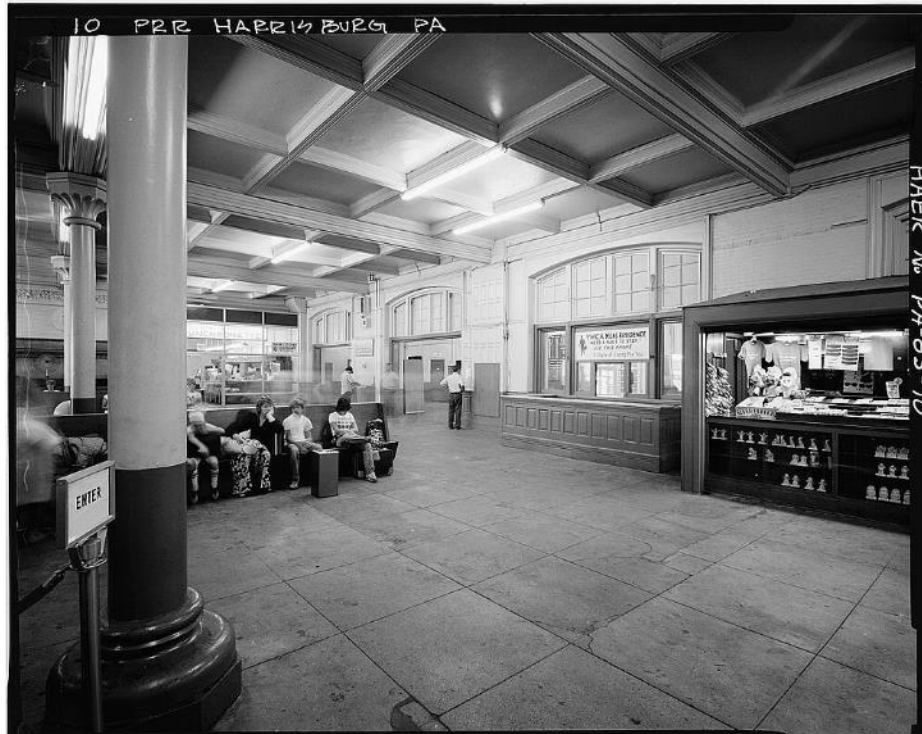
State of Preservation: In 1981, the waiting room is an ad-hoc collection of visually disorganized elements. Benches are pushed up to the fireplaces and fluorescent lights are inappropriately attached to the coffers. Signage is scattered about, hanging from the ceiling and attached to the walls in various locations. The historic features are in themselves intact, but obscured by such accretions as lockers, telephones, candy machines and layers of paint and soiling. The wainscot paneling has been masked or boarded over in a few areas and the original natural finish been painted. All window transoms, which functioned as a clerestory in 1887, are also boarded over and/or painted. Surface mounted piping and conduit are strung on the walls like spaghetti.

Figure 10: 1981 photograph of waiting room (HAER PA-85-10).

Accommodations in the space have not matched the quality of the original fabric. For example, the newsstand (built in the 1960s) along the east wall is a flimsy structure compared to the beautiful oak ticket office across the room. The newsstand was constructed into the wainscot, whose original finish can still be seen behind the magazine rack. The waiting room's concrete floor detracts from the spacious grandeur while creating a parking garage image. Entrances to the men's room and restaurant have been altered, covering historic fabric. The dirty condition of all surfaces is a general problem.

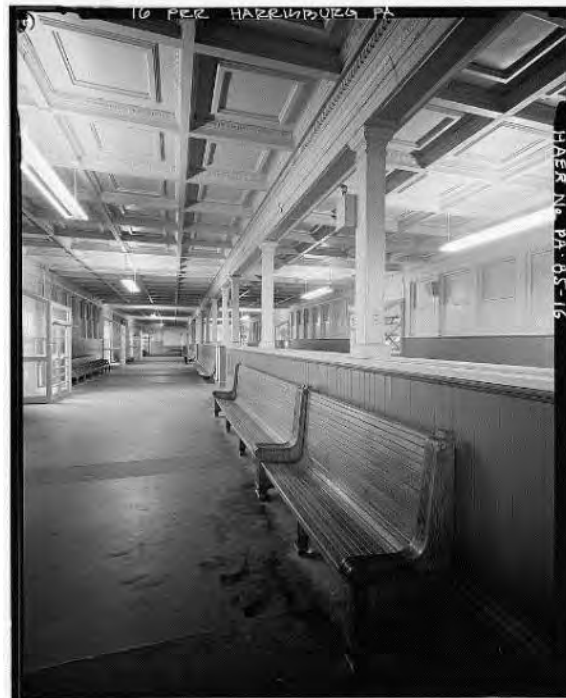
The extension has been partitioned off from the rest of the bridge to create a storage room. The wainscot, originally with a natural finish, has been painted. Many window panes have been removed and boarded over or painted, which makes the space dark. The cast iron newels of the stairways have been replaced by pipes in some locations. The east set of stairs are closed because of the severe deterioration of the treads. The benches have only minor nicks and scratches, although some have been painted. The doors that led to the stairways have been replaced by an aluminum vestibule.

*Figure 12: 1981 photograph of passenger bridge/concourse (HAER PA-85-16).*

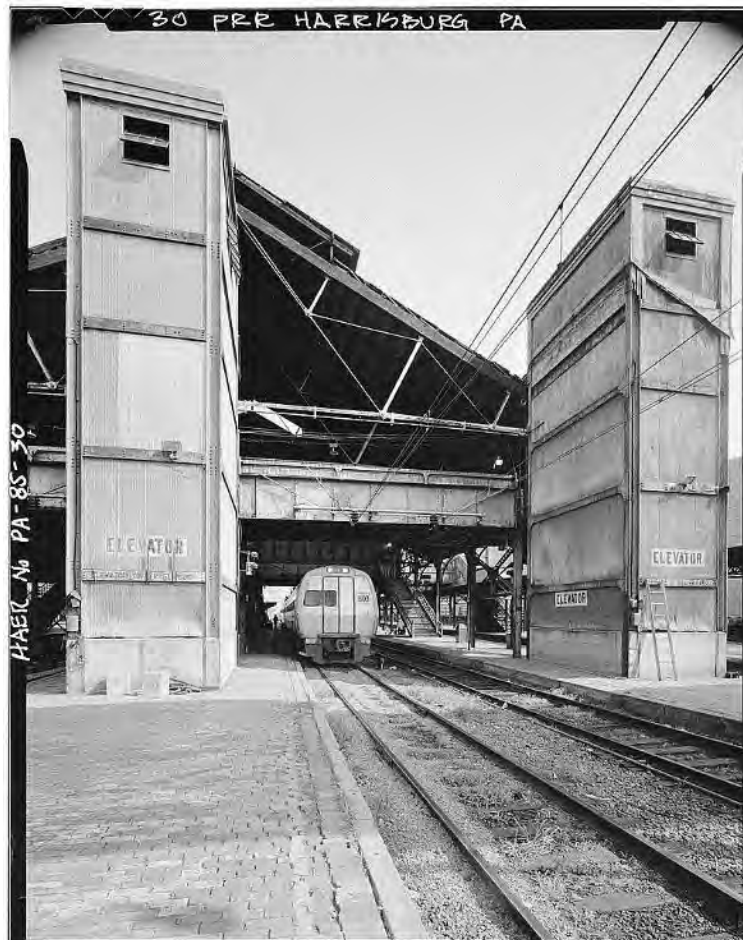
“The majority of the main structural members are between 80 and 95 years old and have not been even marginally maintained. Although there is considerable evidence of previous repairs to the columns and metal truss members, there has obviously been no routine maintenance program for a long period of time. It is most unfortunate that the roof was allowed to deteriorate completely and expose the members to the elements.”

Figure 15: 1981 photograph showing the passenger bridge and elevators (HAER PA-85-30).

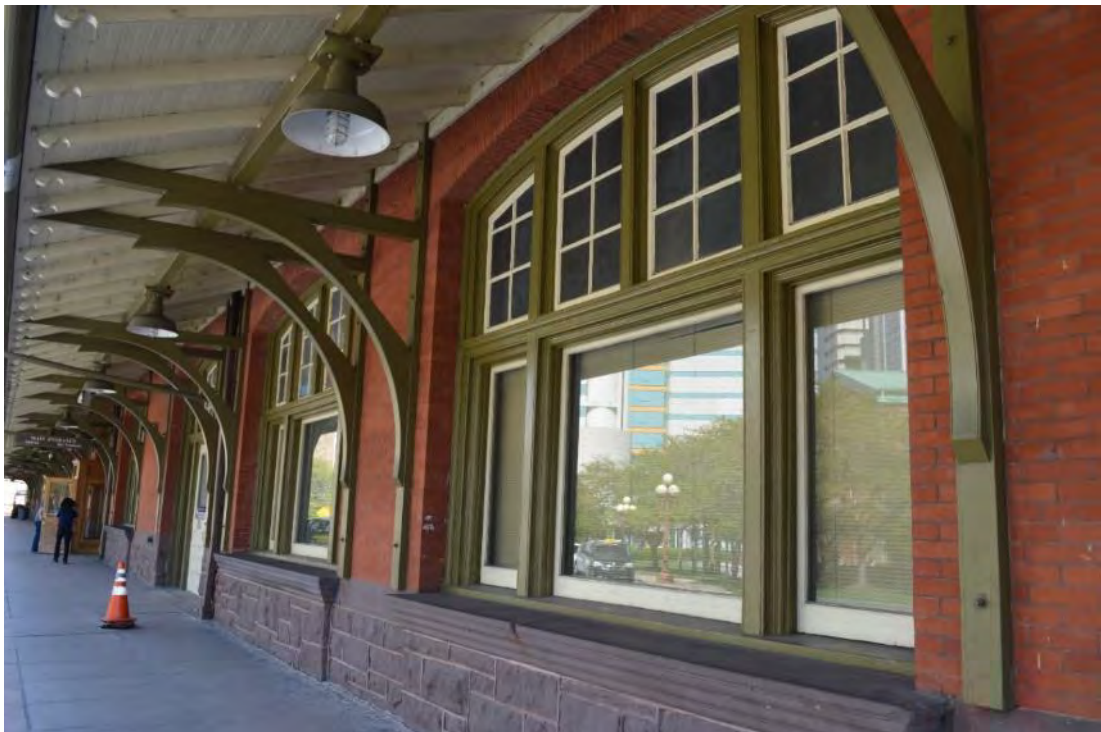
*Photograph 10: Detail of passenger station facade showing first story windows and canopy support brackets, looking north-northeast. Note the brownstone watertable.*

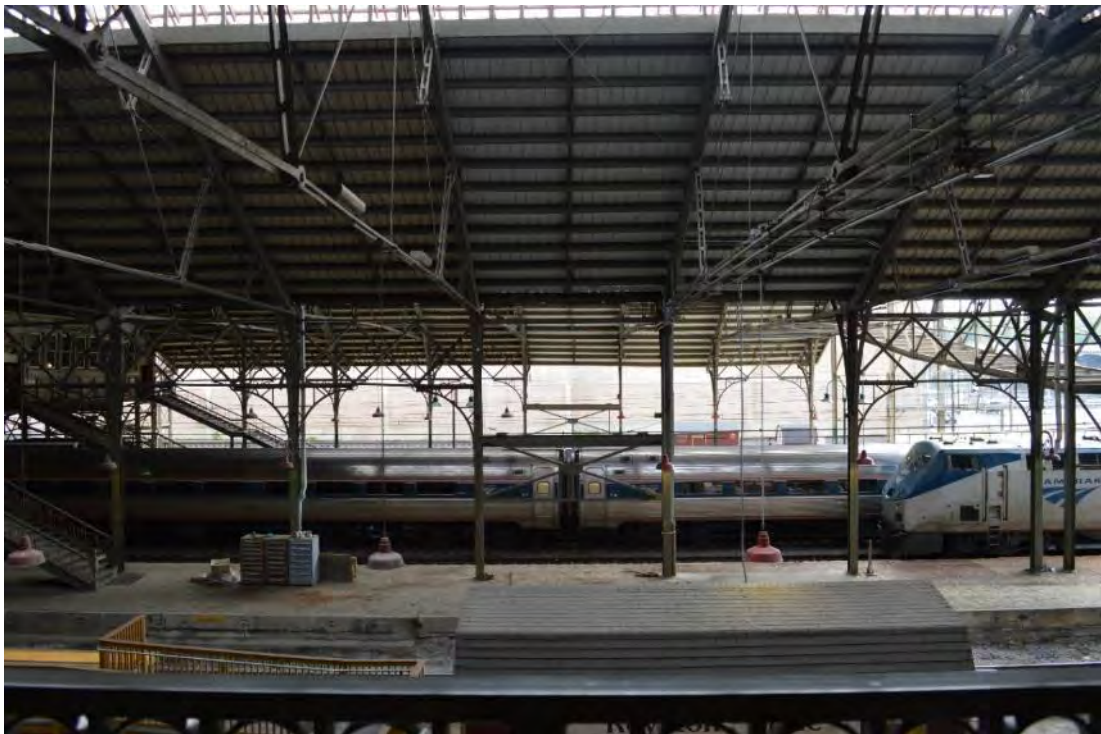
*Photograph 16: View of former location of baggage bridge, demolished 2018, looking east.*

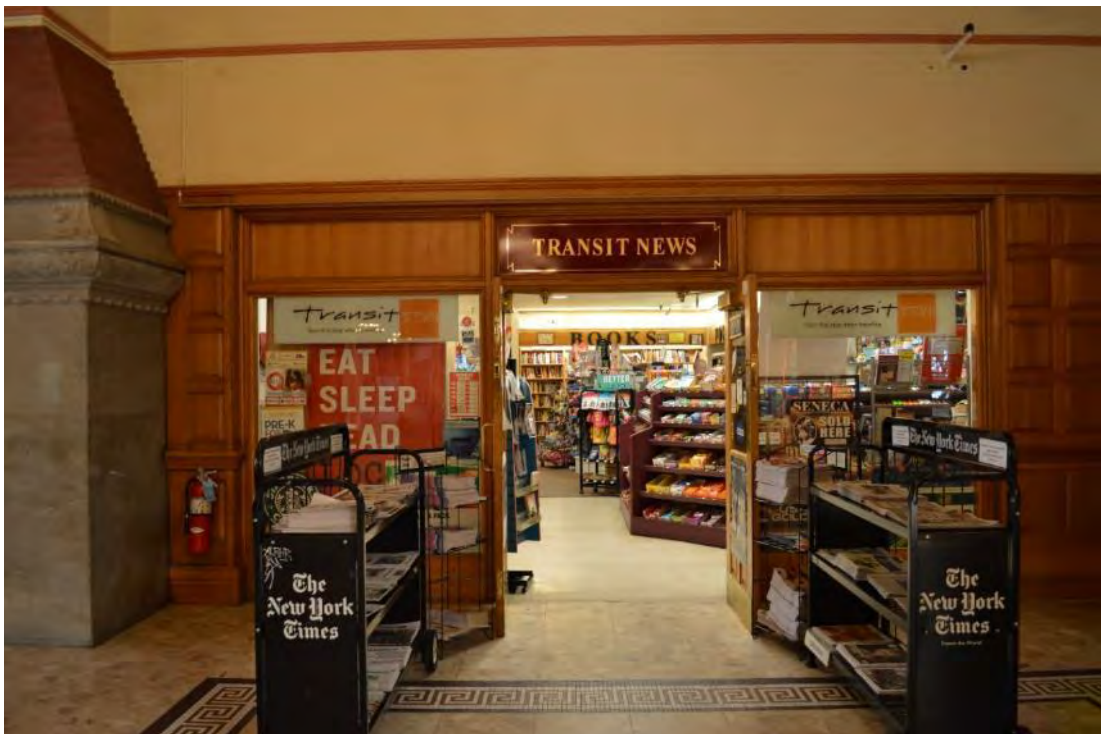
Photograph 23: View of news stand in main waiting room, looking north.
