# HISTORIC STRUCTURE REPORT

## Harrisburg Transportation Center

## **Harrisburg Transportation Center Preliminary Design Project City of Harrisburg, Dauphin County, Pennsylvania**

October 2018

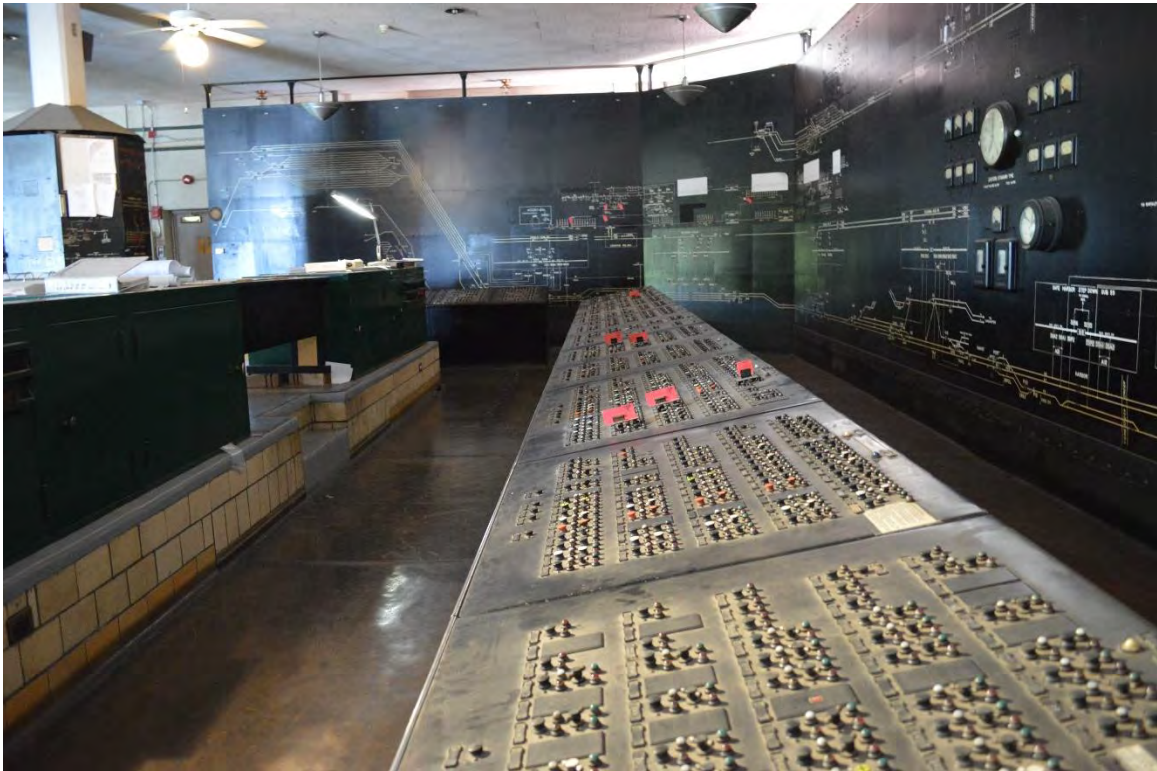
Photograph 8: Westinghouse four-panel console.

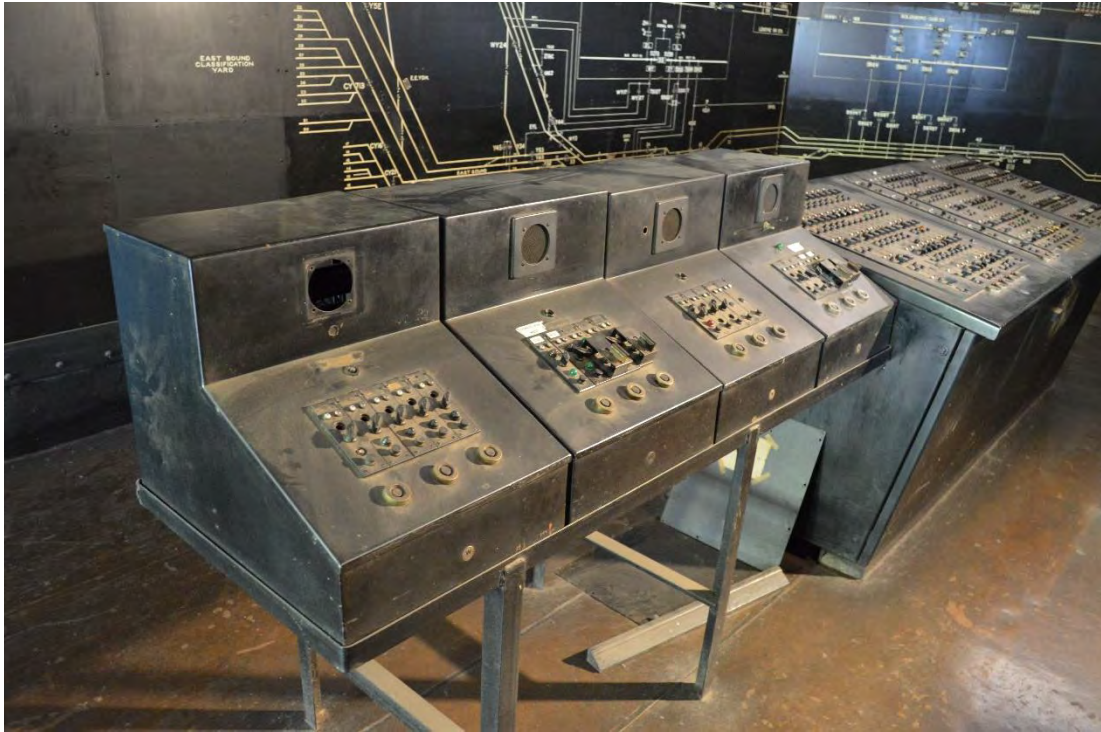
Photograph 10: Westinghouse three-panel console.

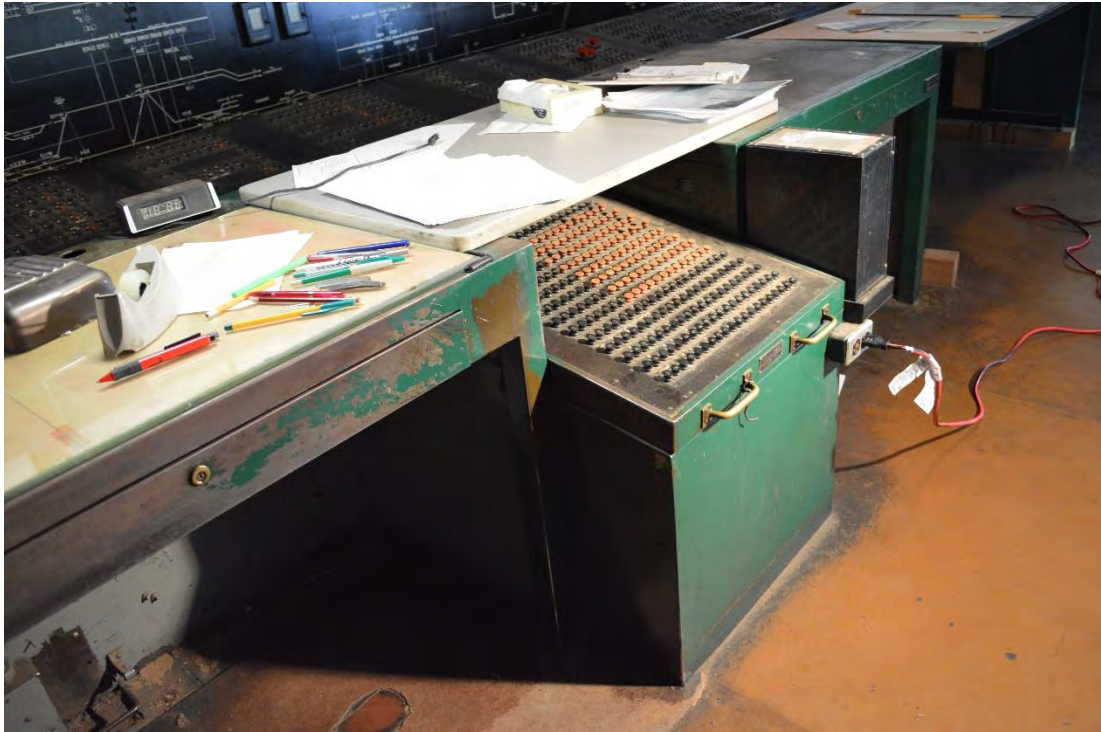
Photograph 12: Two Kellogg Switchboard & Supply Co. signal control units.

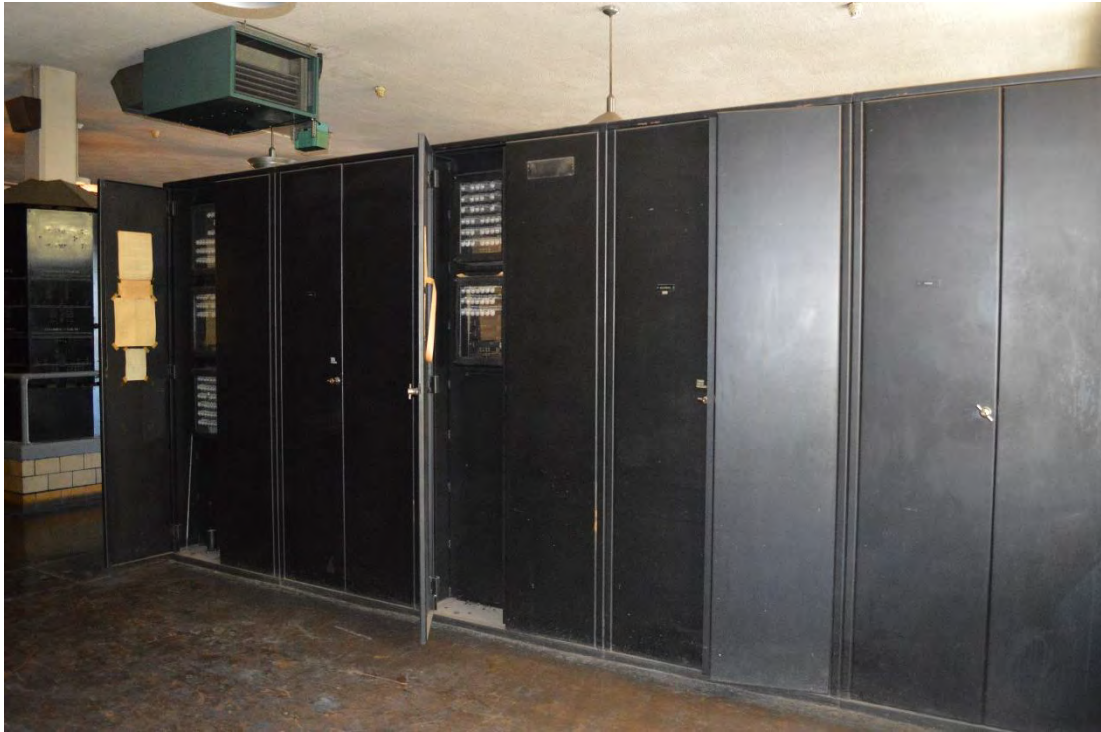
Photograph 14: Five rows of General Electric equipment cabinets (left).

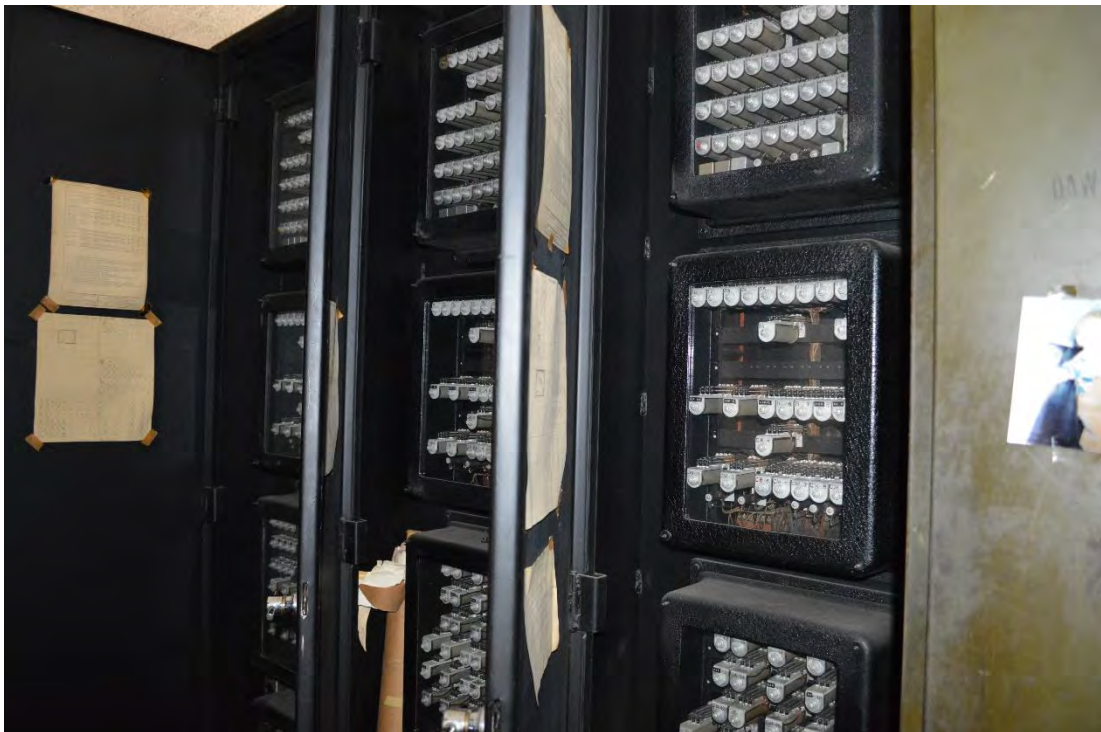
Photograph 15: Detail of General Electric Equipment Cabinets.
