# HISTORIC STRUCTURE REPORT

## Harrisburg Transportation Center

## **Harrisburg Transportation Center Preliminary Design Project City of Harrisburg, Dauphin County, Pennsylvania**

October 2018

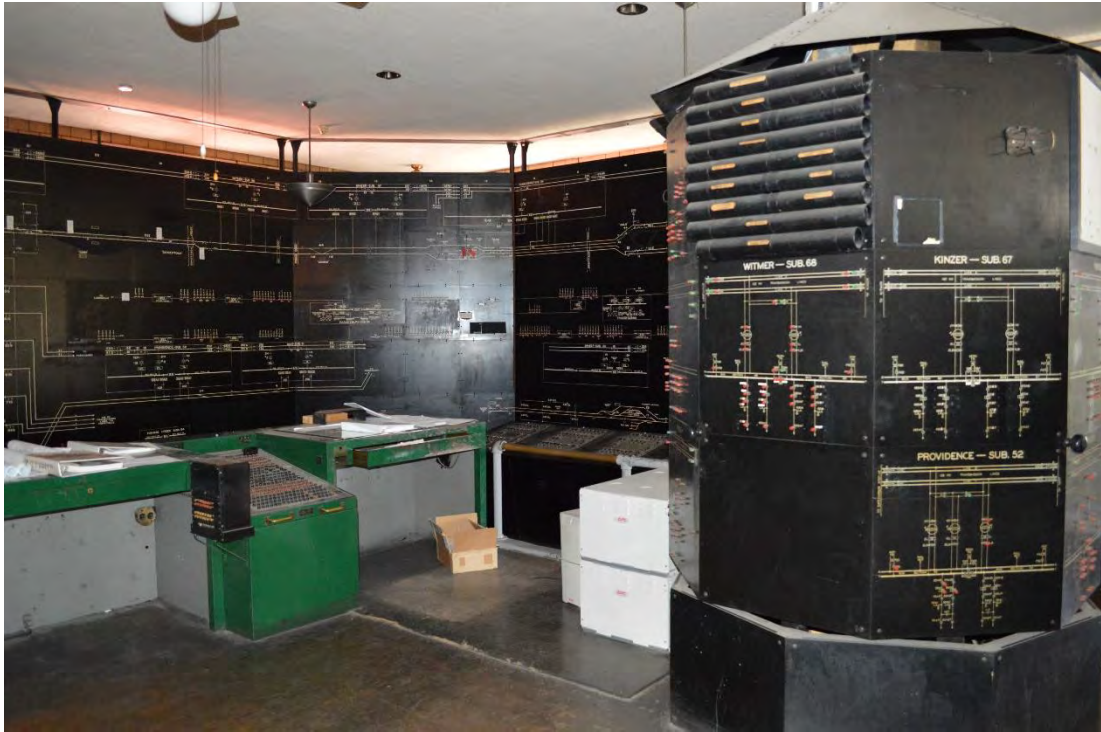
Photograph 6: General Electric Octagonal Display (1 of 2).

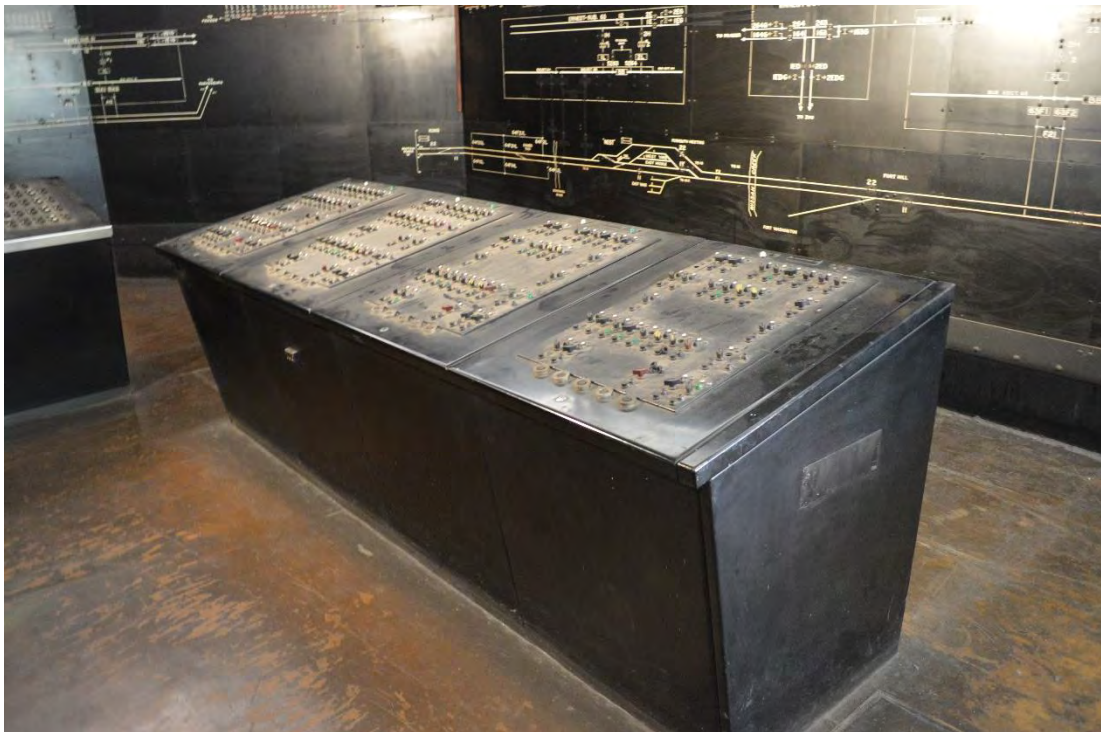
Photograph 7: General Electric Octagonal Display (2 of 2).

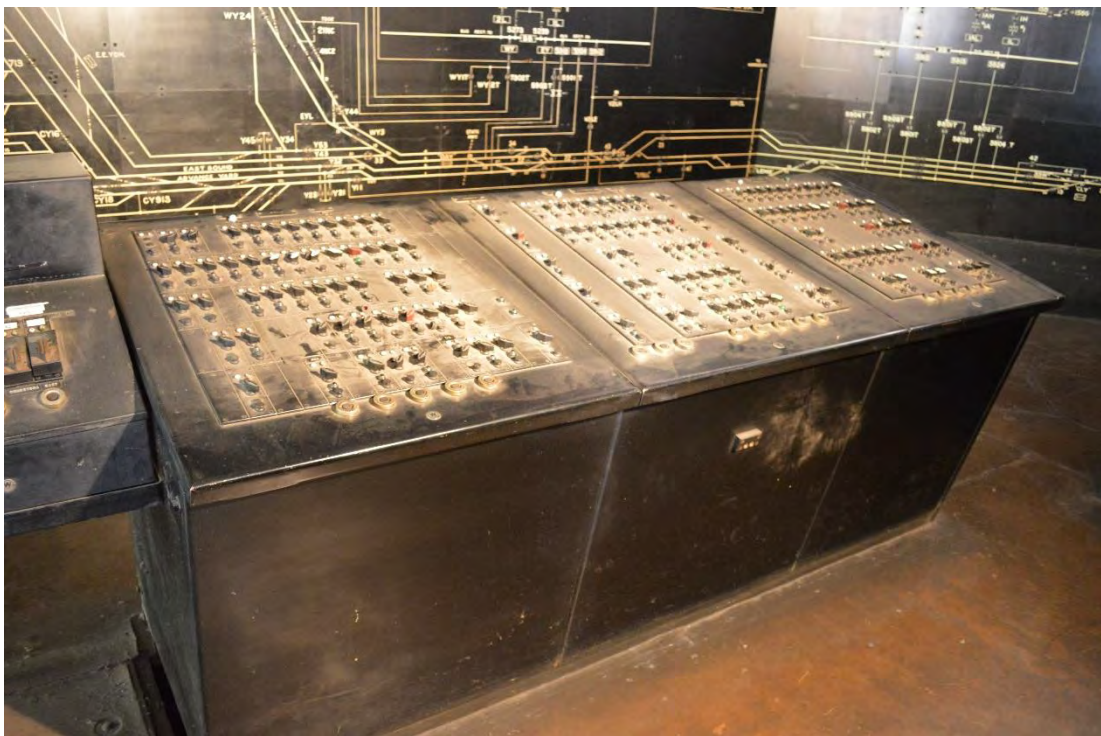
Photograph 9: Westinghouse twelve-panel console.
